# FACT SHEET Updated Information on Lead and Drinking Water

## Lead Goosenecks are a potential issue for some homes built prior to the late 1940s

### Bremerton Water Customers Can Check for Lead "Gooseneck" Pipes with New Online Tool

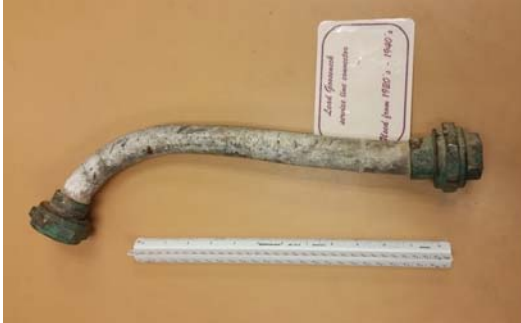
There are no lead customer service lines in Bremerton's system and most of the older customer water services in Bremerton were connected to the water main with copper pipe. However, prior to the late 1940s short pieces of lead pipe (about 16" long) were sometimes used on galvanized service lines to connect the water main to the water meter. These pipe segments often took the shape of a goose's neck, and are referred to as "lead goosenecks." They are difficult to locate because they are underground, usually under the street, and their locations were not routinely documented. Above is a photo of a lead gooseneck and below is a diagram of where they are located on the service line. Galvanized water service lines on the customer side of the meter do not pose this issue.

Locations with the greatest likelihood of a lead gooseneck are those with galvanized service lines from the distribution main to the meter built 1949 or earlier connected to a water main installed 1949 or earlier, mainly to the east of Naval Avenue in West Bremerton. Only some older services used galvanized pipe with a lead gooseneck for the flexible connection - most did not need a connector or used copper. Only about 300 galvanized services remain in Bremerton's system and of those, only about 50 are estimated to have a lead gooseneck.
